TESTS OF FULL SCALE BRICK VENEER STEEL STUD WALLS TO DETERMINE STRENGTH AND RAIN PENETRETION CHARACTERISTICS

TESTS OF FULL SCALE BRICK VENEER/STEEL STUD WALLS TO DETERMINE STRENGTH AND RAIN PENETRATION CHARACTERISTICS

PROJECT IMPLEMENTATION DIVISION
CANADA MORTGAGE AND HOUSING CORPORATION

Robert G. Drysdale, P.Eng.
Professor

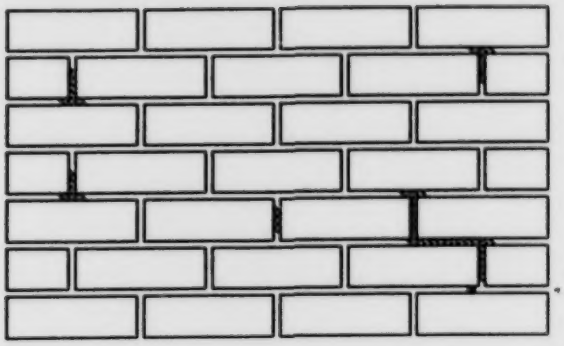
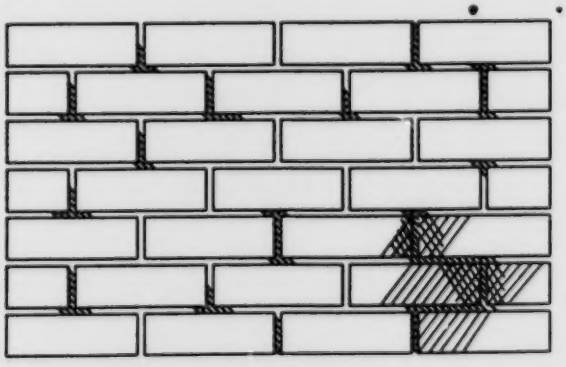
FIGURE 4.2 PROGRESS OF DAMPNESS IN JOINTS DURING THE CAVITY PRESSURIZED TEST OF WALL3

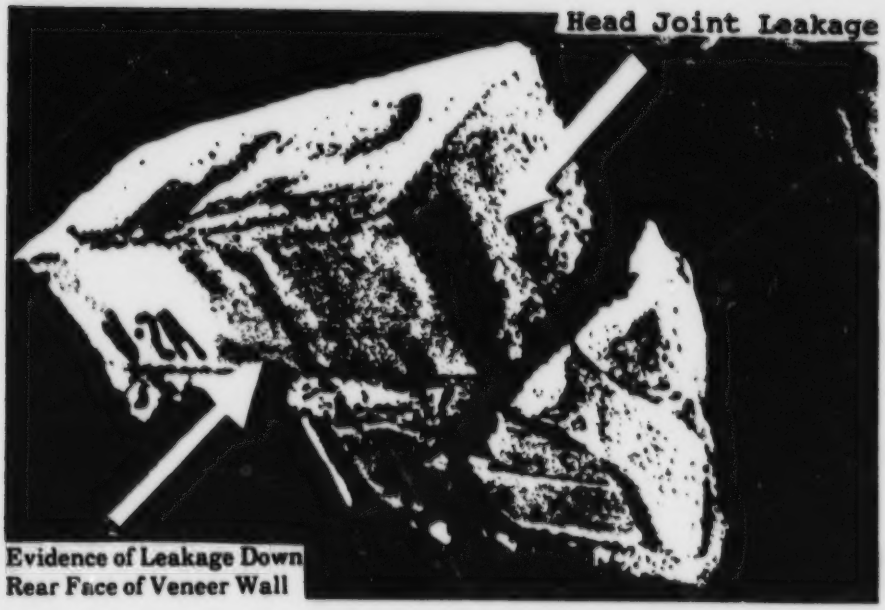
a)

FIGURE 4.8 LEAKAGE PATHS OBSERVED FROM DYE STAINING

areas that had experienced heavy head joint leakage. Therefore, it is questionable whether this staining was a result of direct leakage through the bed joint or of water from the leaking head joints migrating back into the wall. The photograph in Figure 4.8(b) shows the limited staining occurring in a typical bed joint removed from the wall. Again the leakage occurring in the head joint is evident from the staining pattern which is more concentrated near the mid length of the brick.

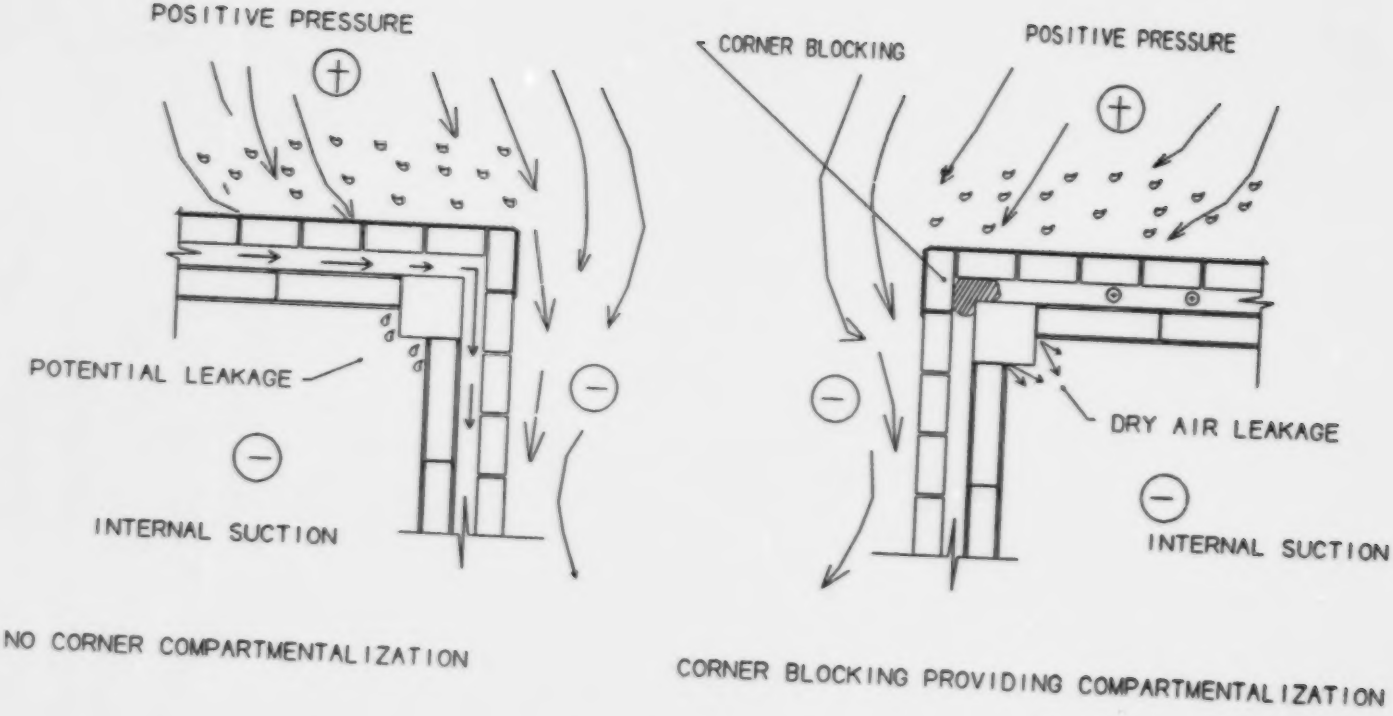
If the cavity is not comparted, then positive and negative wind pressure can cause air movements within the cavity and prevent equalization of the cavity pressure with the external pressure. In practice the most critical wall locations for compartmentalization are at building corners. At these locations air movement due to pressure differences and wind turbulence can draw rain into the cavity and expose potential leakage paths in the backup wall to moisture, as shown in Figure 4.9.

a) No Corner Compartmentalization

b) Corner Blocking for Compartmentalization

Compartmentalization can be achieved in the field by partitioning the cavity horizontally at floor levels with shelf angle details, and vertically within storey heights at intersecting walls and at building corners with a closed cell compressible filler or solid metal flashing spanning between the backup wall and into vertical movement joints. Discussions with many visitors to the laboratory revealed a fairly wide spread lack of concern for this important detail in either the design or construction stages of brick veneer walls.

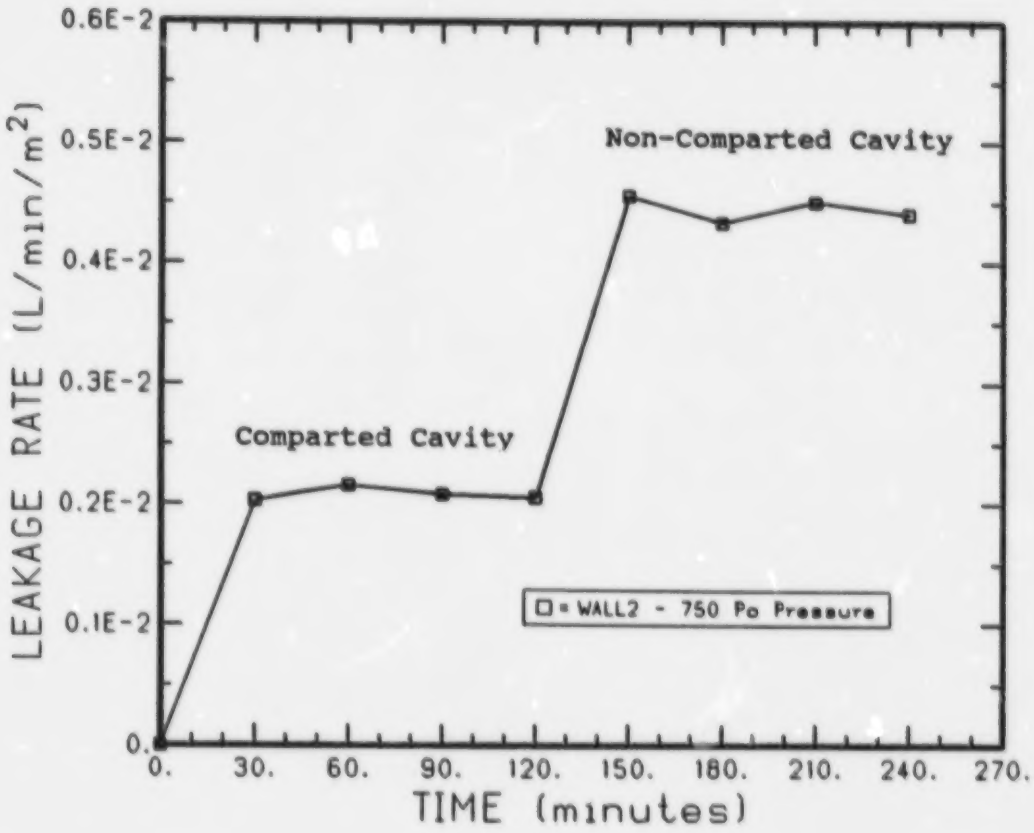
For WALL2, an attempt was made to study the leakage response to variations in the degree to which compartmentalization had been achieved. A steady leakage rate was reached at an air pressure of 750 Pa with a gradient of 21 Pa across the veneer. After 2 hours of testing, the backup wall vents were slightly opened while maintaining the 750 Pa load. The pressure gradient across the veneer increased to 100 Pa and the steady state rain leakage rate rose from 0.0020 to 0.0045 L/min/m^2. The results are shown in Figure 4.10.

FIGURE 4.10 INFLUENCE OF COMPARTMENTALIZATION

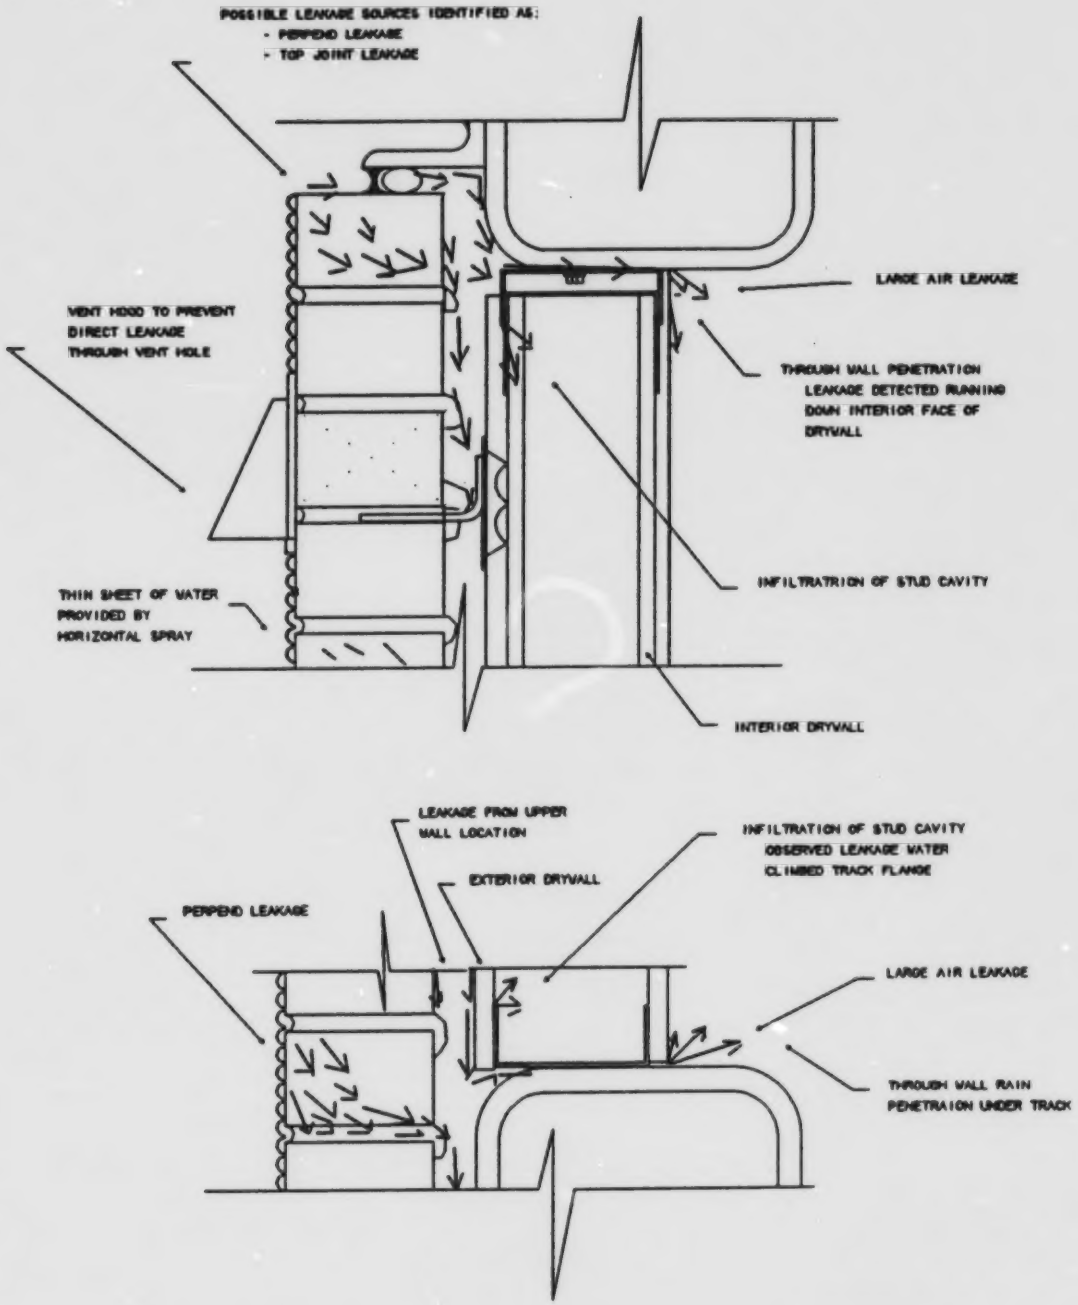
During the test, water was observed as bubbling under the bottom track and running from upper track locations down the interior face of the backup wall. Also leakage between the end members and the specimen frame was noted and in all cases deterioration of the gypsum board was observed. In addition to these leakage paths, observation through viewing ports revealed that water was carried up between the exterior gypsum board and the bottom track flanges and deposited in the track. This finding is quite significant considering the potential for moisture build up in the bottom of the cavity.

The leakage paths observed during the test are illustrated in Figure 4.11. After the initial tests, the perimeter of the specimen was properly sealed to the specimen frame, thereby preventing further damage from water penetration. Tests of the repaired system continued after cracking of the veneer and no "Through-Wall" rain penetration was observed.

FIGURE 4.11 OBSERVED LEAKAGE PATHS DURING TESTING WITH SUB-STANDARD PERIMETER SEALING OF THE AIR BARRIER IN WALL1

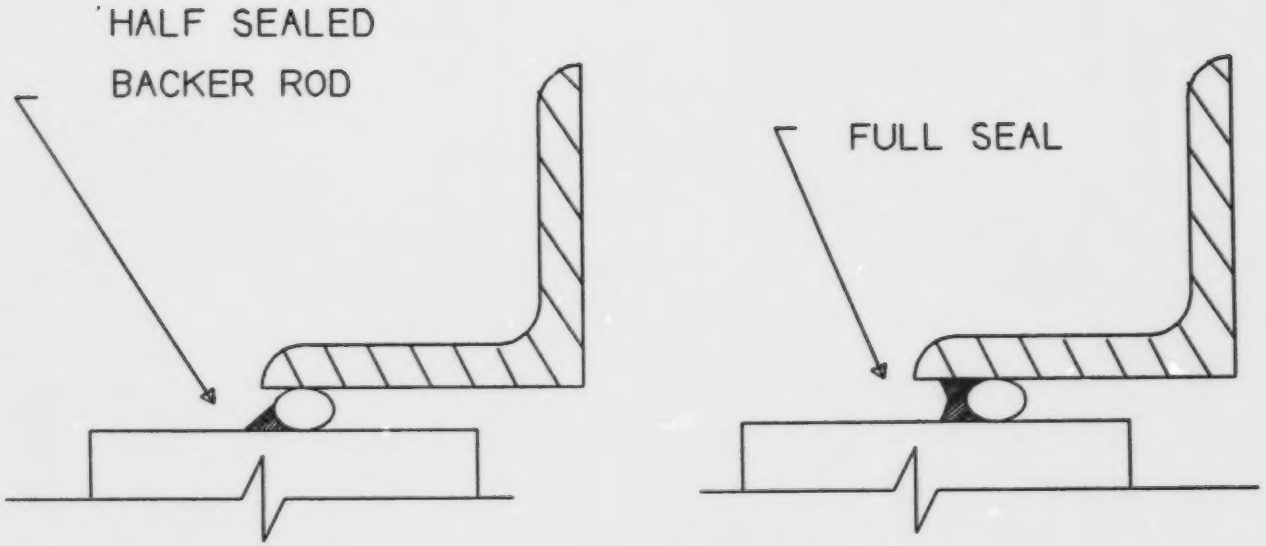
sealed joint. The poorly sealed joint was constructed by improperly caulking in front of the foam backer rod. Both the fully and poorly sealed details are shown in Figure 4.12.

When the cavity was pressurized, the poorly sealed top joint allowed penetration of water into the cavity along the under side of the top shelf angle. The presence of water in this location combined with the effects of gravity flow and a small driving pressure force led to infiltration of the stud cavity. Although the observed leakage was very small and basically unmeasurable, it does indicate a vulnerability to moisture related problems.

a) Poor Seal **b) Full Seal**

FIGURE 4.12 SEAL DETAILS FOR VENEER MOVEMENT JOINT FOR WALL2

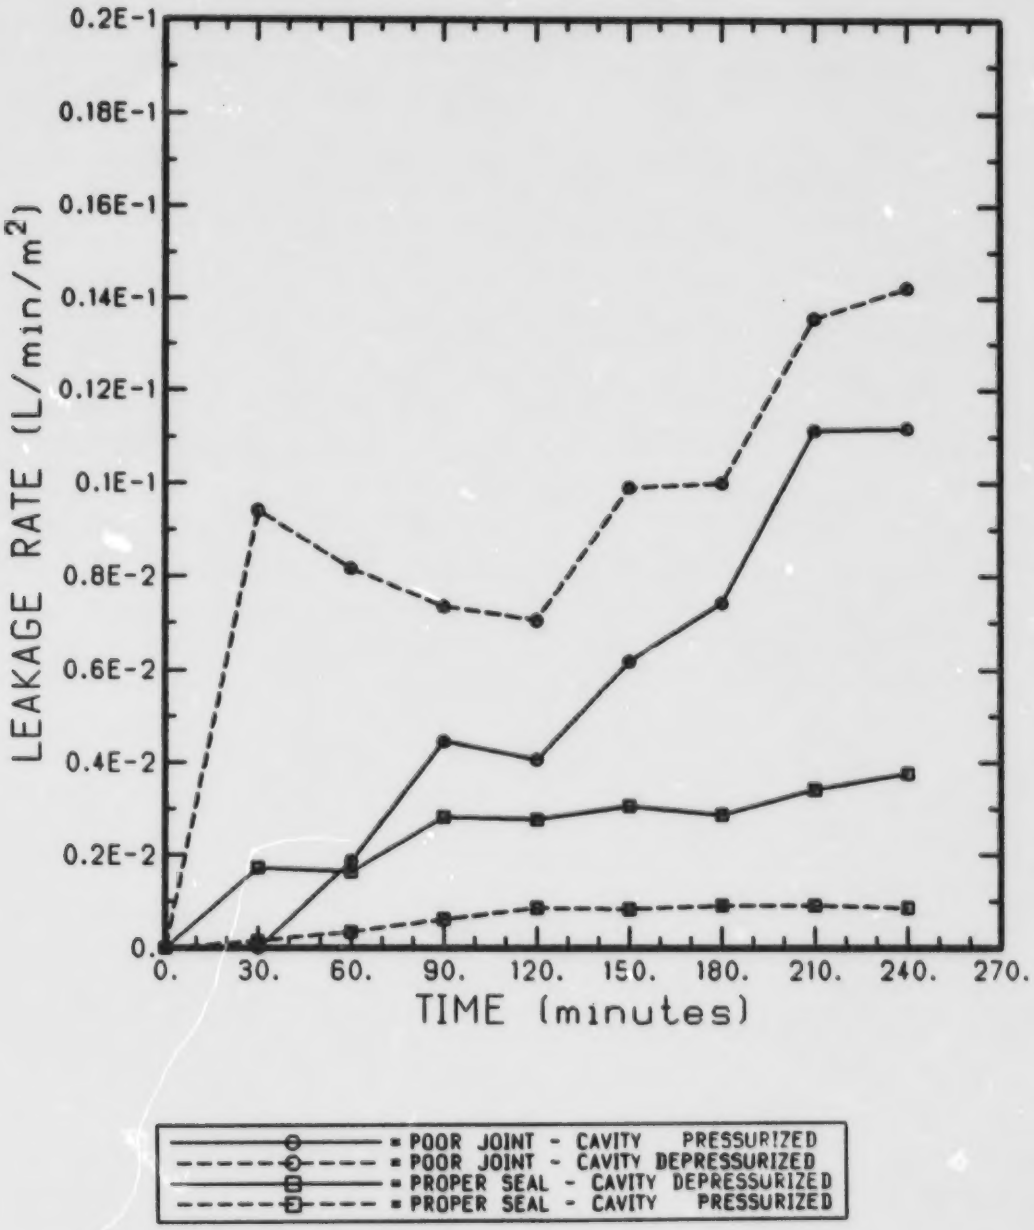
At 500 Pa air pressure, water was observed tricking down the cavity face of the veneer in the early stages for both the cavity pressurized and depressurized conditions for the test with the poorly sealed top joint. The results presented in Figure 4.13 show that in all cases the leakage rates were greater than those obtained after the joint was fully sealed. Possibly more significant than the actual leakage rates recorded were the observations of water in the stud cavity (ie. between the gypsum board sheathings).

FIGURE 4.13 INFLUENCE OF POOR MOVEMENT JOINT DETAIL ON LEAKAGE RATE

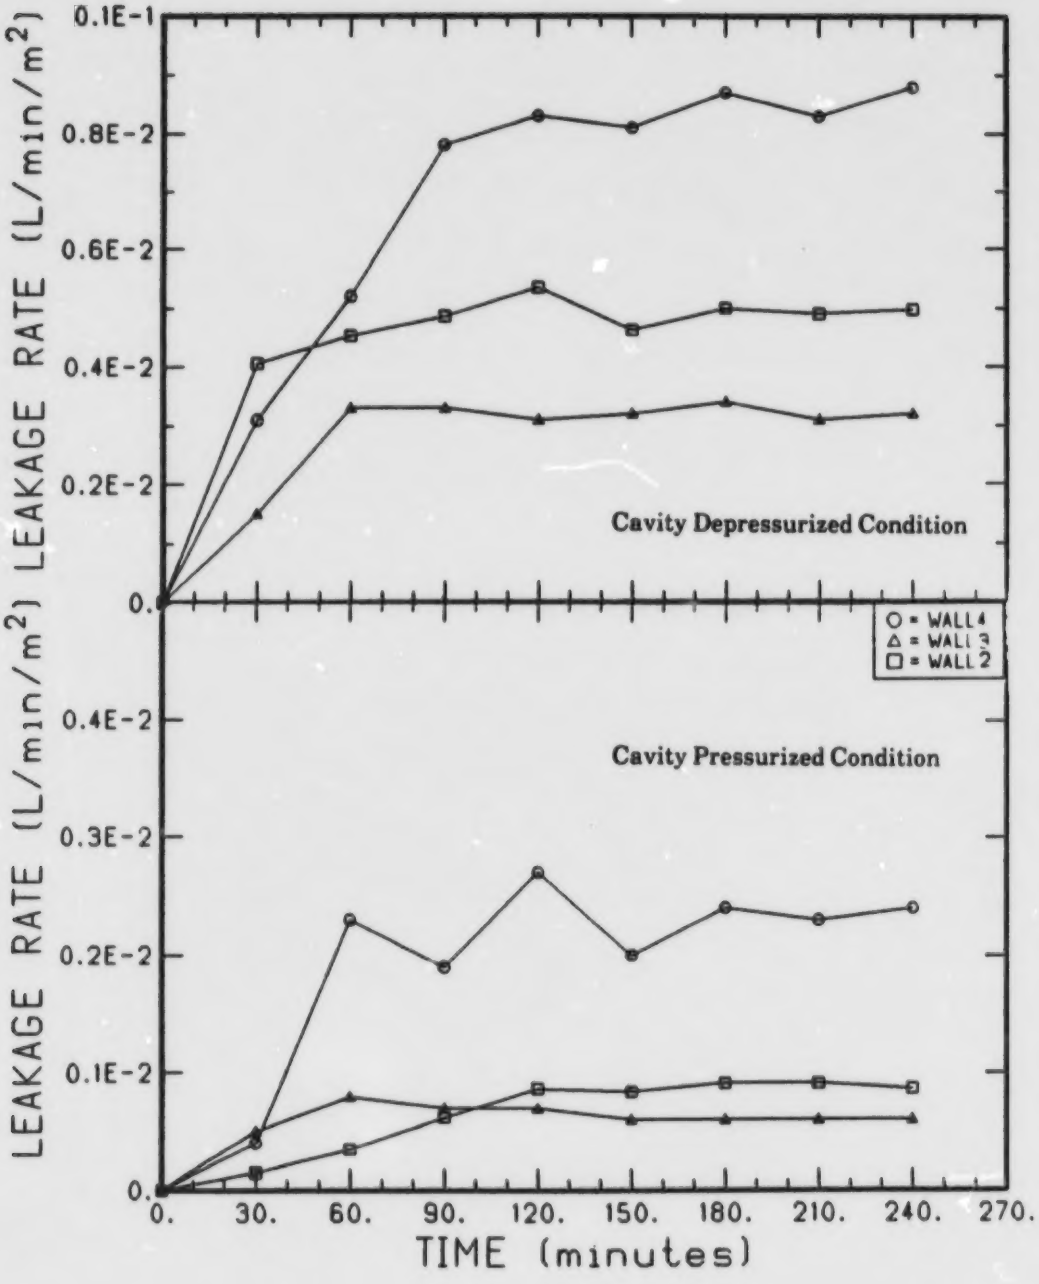
During the rain penetration testing of WALL4, it was observed that the leakage rates were significantly higher than those obtained for the other specimens. The leakage rates are shown in Figure 4.14 for both cavity pressure conditions and the responses obtained from WALL2 and WALL3 are also included for comparison.

FIGURE 4.14 INFLUENCE OF POOR MORTAR JOINT ON LEAKAGE RATE

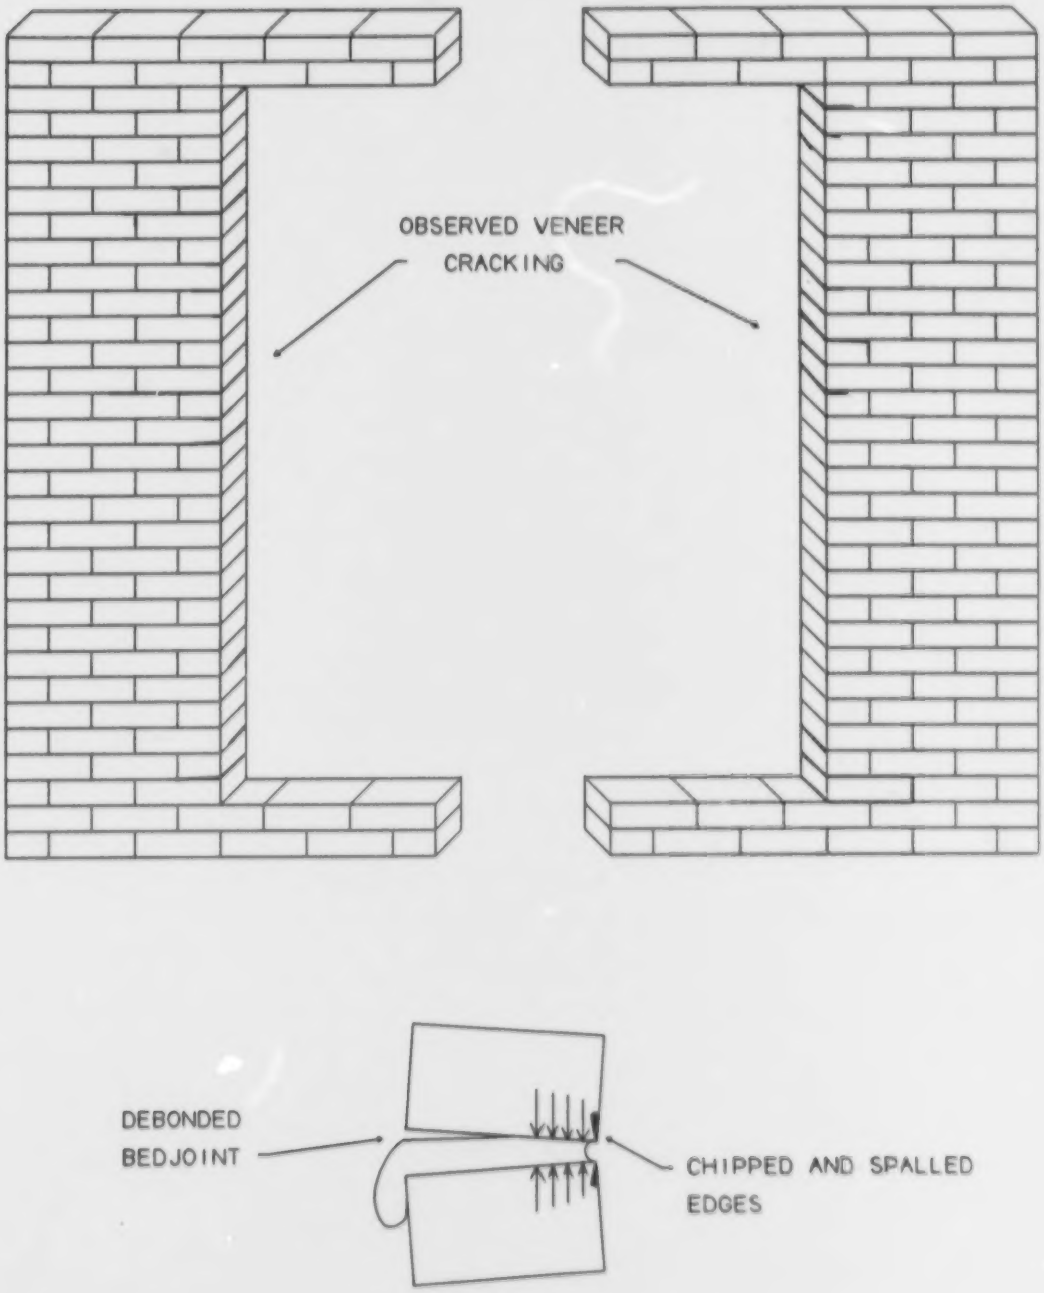
After the test, the veneer was examined for signs of distress or cracking. The large opening and recessed window frame left the ends of brick units exposed around the window. The areas where cracks were observed in the form of debonding along bedjoints are indicated in Figure 5.7. At several crack locations, the brick itself appeared to have suffered some edge spalling. This chipping or slight spalling along the bricks edges is also illustrated in Figure 5.7.

FIGURE 5.7 VISIBLE SIGNS OF CRACKING AROUND WINDOW IN WALL4

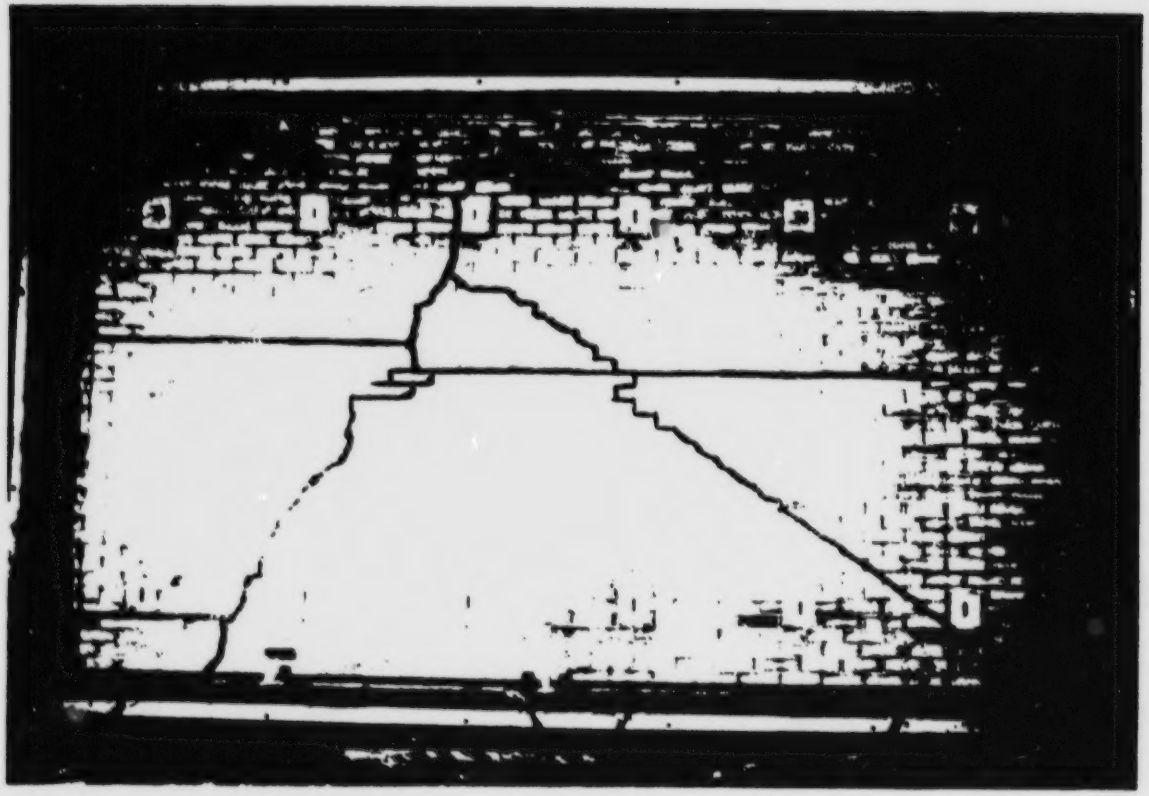
FIGURE 5.16 CRACK PATTERN AT FAILURE – WALL2

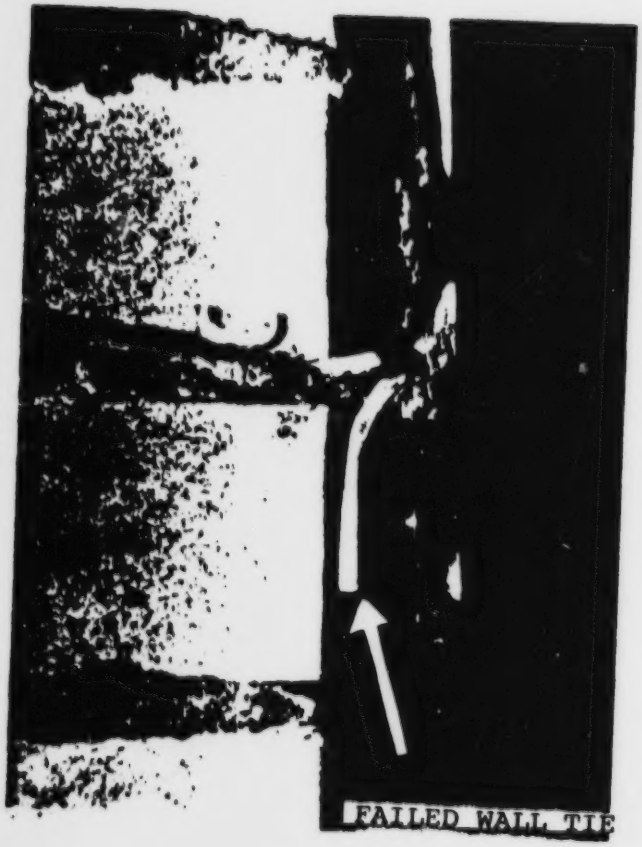
FIGURE 5.17 CONDITION OF WALL TIE AFTER FAILURE – WALL2

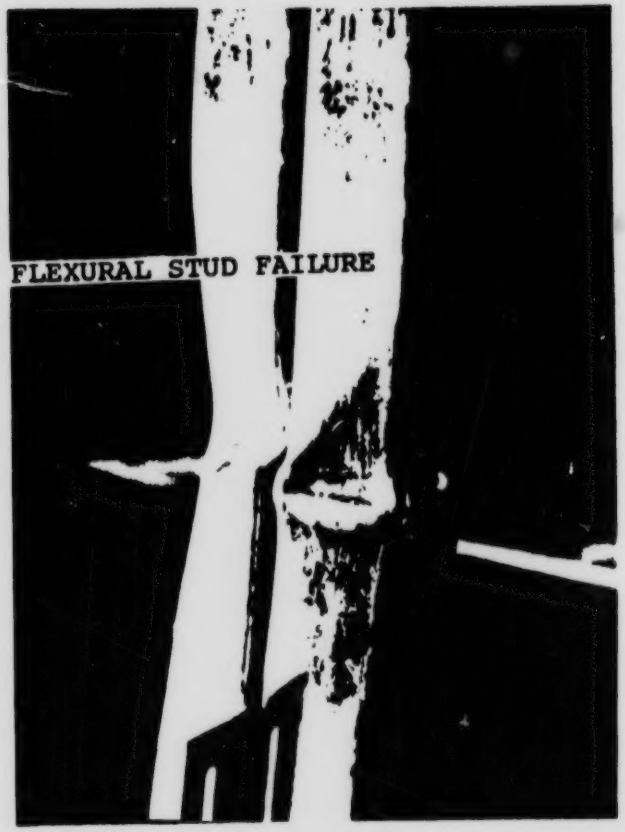
FIGURE 5.23 STEEL STUD FLEXURAL FAILURE – WALL3

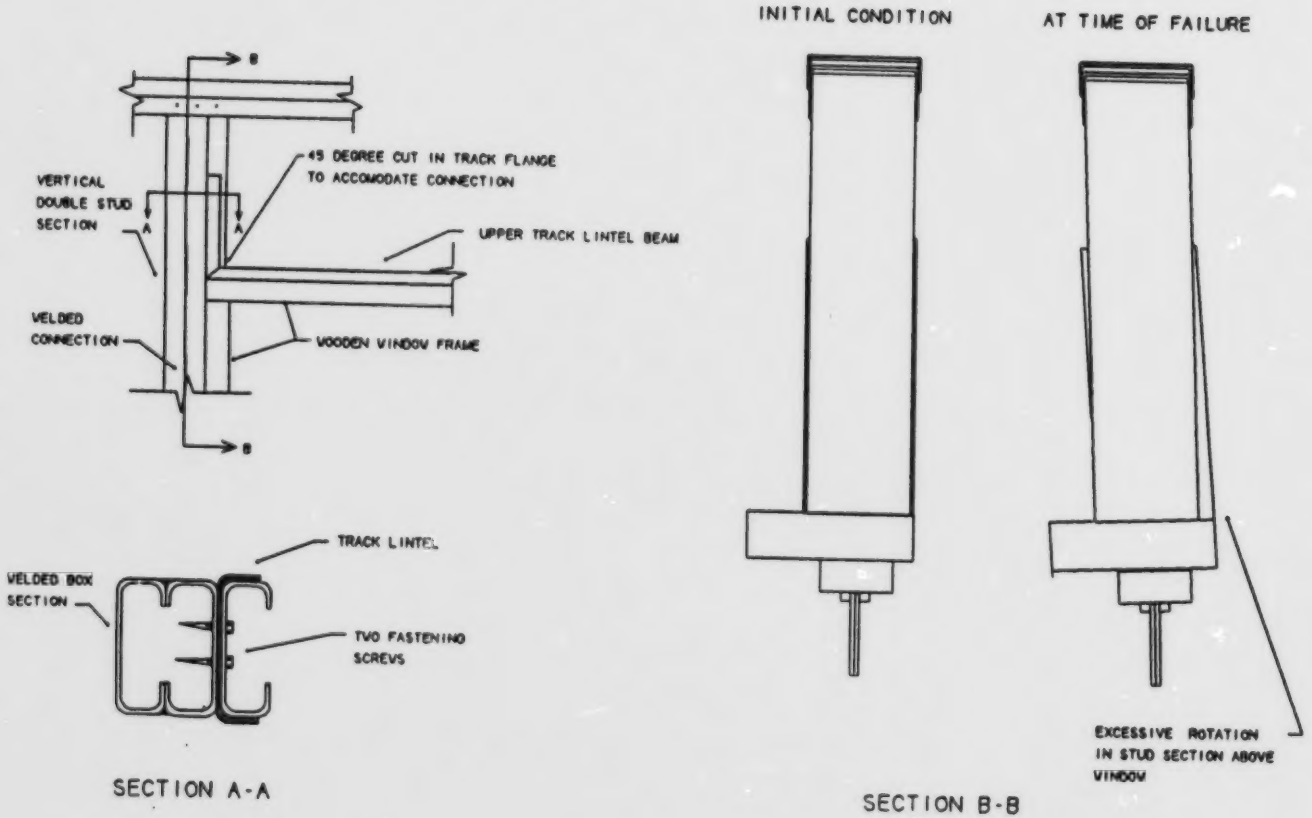
FIGURE 5.26 FAILURE OF BACKUP PANEL AT WINDOW OPENING

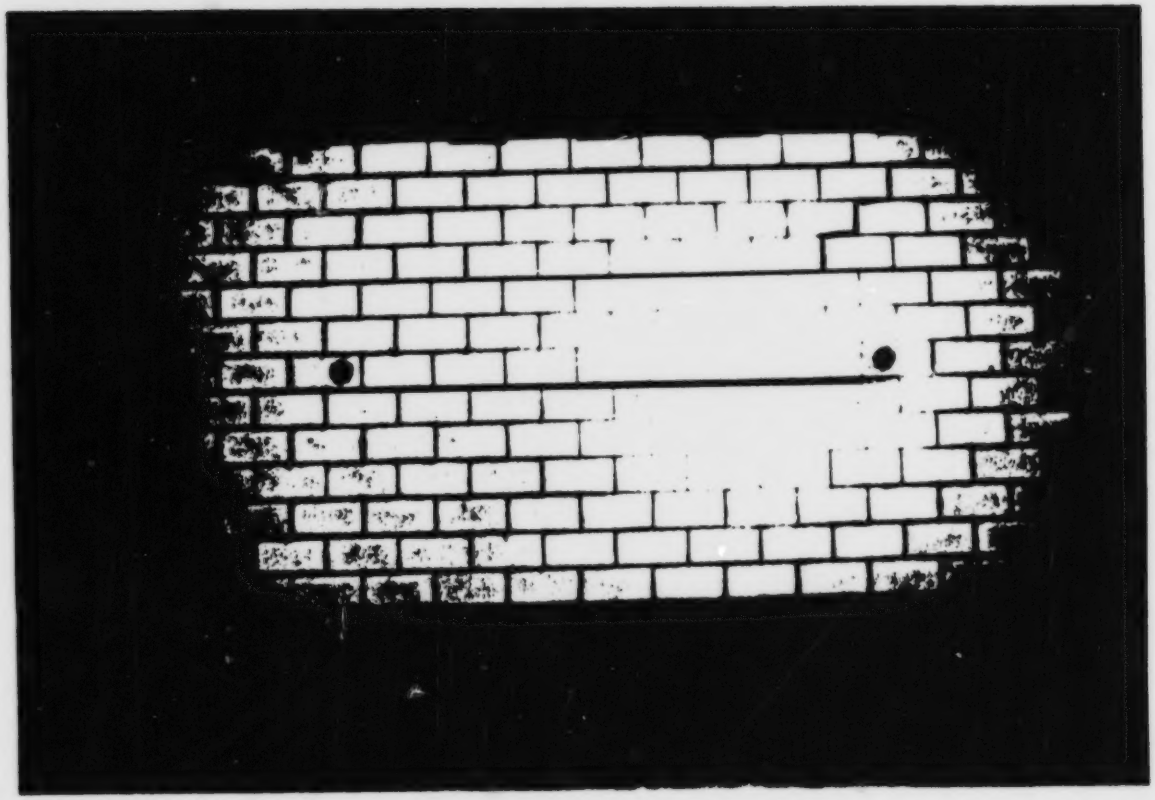
FIGURE 5.28 CRACK PATTERN AT FAILURE – WALL5
